NEWTOWN, CONNECTICUT

# HATTERTOWN POND DAM CT 00313

## PHASE I INSPECTION REPORT NATIONAL DAM INSPECTION PROGRAM

MAY 1981

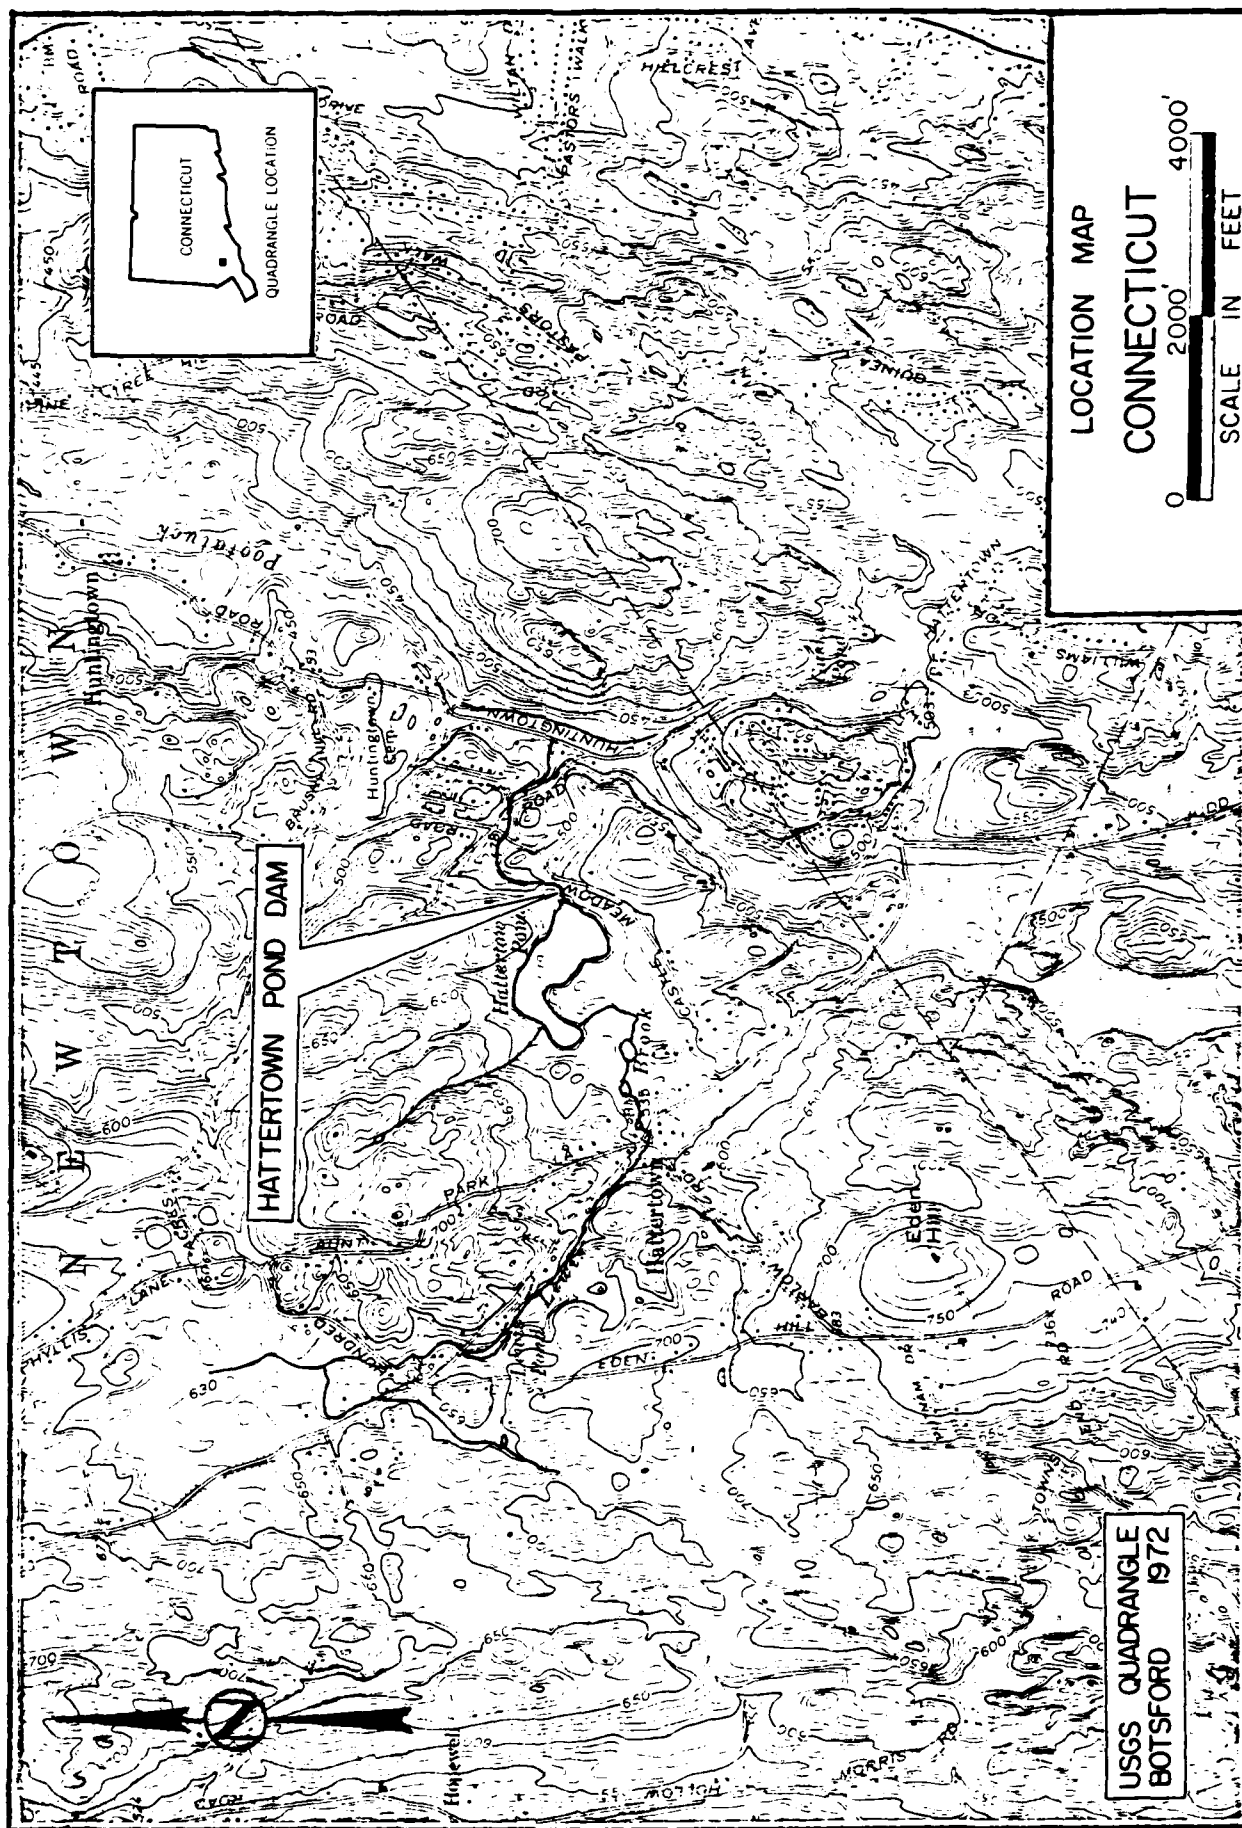
OVERVIEW PHOTO-HATTERTOWN POND DAM

Based on the visual inspection of the site and the past performance of the dam, the facility is judged to be in very poor condition. Evidence of recent breaches, erosion of the embankment, seepage through the dam, and growth of large trees and brush on the dam were noted. In addition, the spillway section was in a state of extreme disrepair.

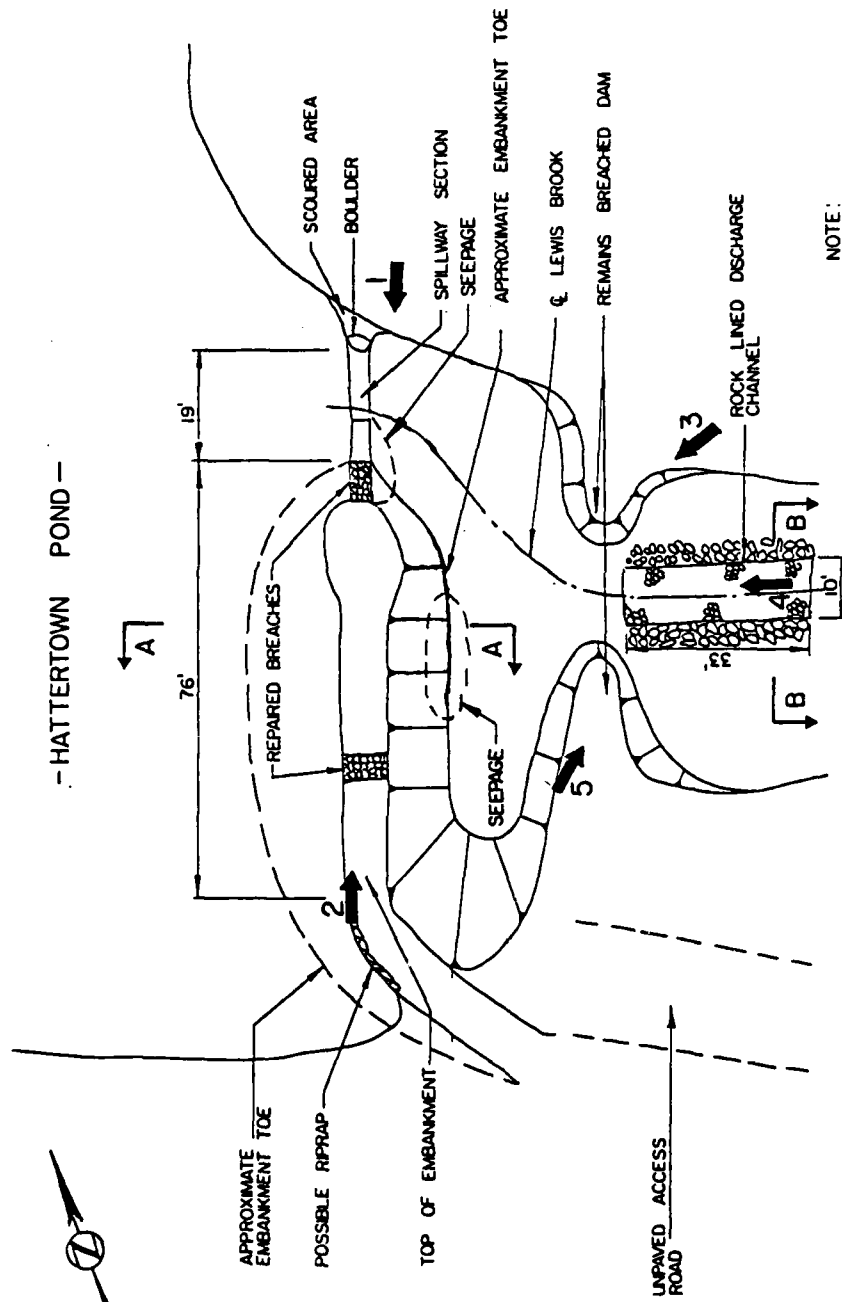
e. Downstream Channel — The downstream channel follows the natural path of Lewis Brook through a heavily wooded area. Lewis Brook then passes through another breached dam approximately 1,200 feet downstream of the pond before flowing under Castle Meadow Road (Photo 6). The 6-foot-high by 7-foot-wide breach and the 6-foot-high by 15-foot-wide bridge culvert compose the first downstream constriction.

NOTE:  
PHOTO 6 WAS TAKEN WHERE LEWIS BROOK  
FLOWS UNDER CASTLE MEADOW ROAD (SEE  
DRAINAGE AREA MAP IN APPENDIX D FOR  
THE ROAD LOCATION).

Photo 6 Breached dam near Castle Meadow Road bridge culvert.
